The effect of cathodic protection on the stress corrosion characteristics of 300M low alloy steel

THE EFFECT OF CATHODIC PROTECTION
ON THE STRESS CORROSION CHARACTERISTICS OF
300M LOW ALLOY STEEL

A THESIS

MASTER OF SCIENCE IN METALLURGICAL ENGINEERING

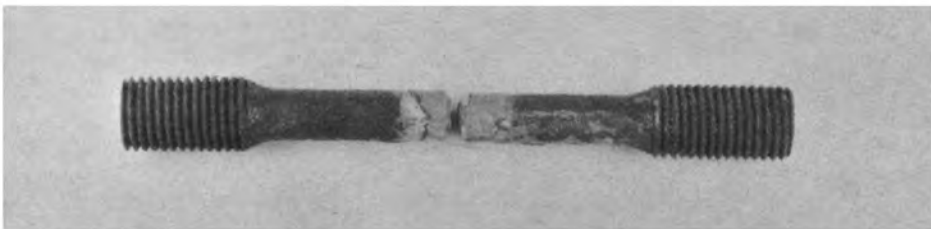
FIGURE 9

BARE CONTROL SPECIMEN

VACUUM CADMIUM SPECIMEN

VACUUM CADMIUM (EXPOSED) SPECIMEN

PHOTOGRAPHS OF FAILED TEST SPECIMENS

Photographs of the test specimens after testing are shown in Figures 9 and 10. As is evident in the photographs, there is corrosion on all specimens after testing. This is evidence of stress corrosion and the possibility of accompanying hydrogen embrittlement. These photographs represent a typical specimen that failed at the 60% NTS stress level.

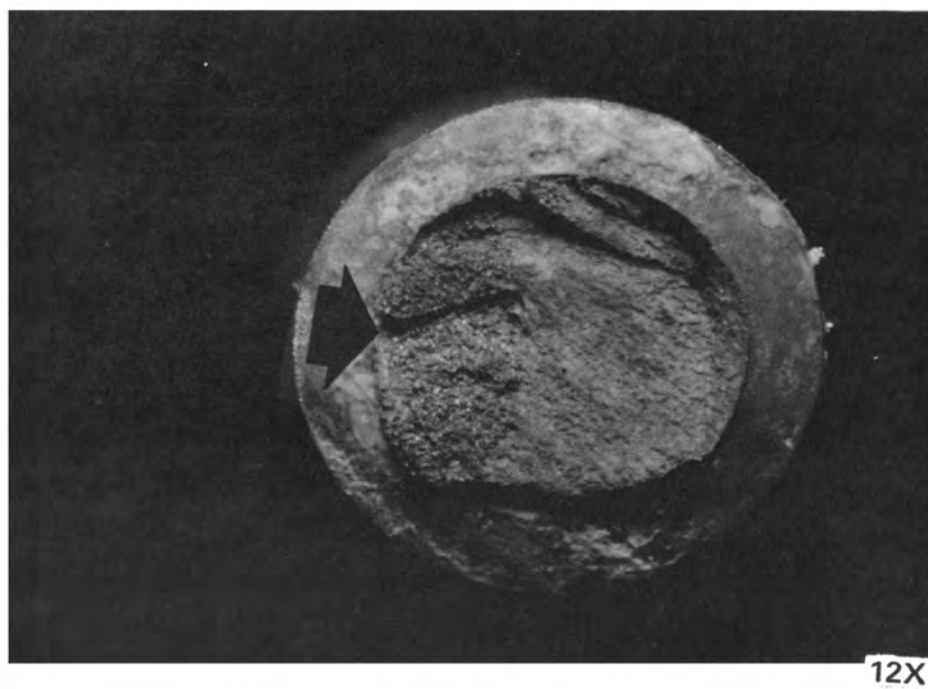
FIGURE 14
MACROPHOTOGRAPHS OF VACUUM CADMIUM FRACTURE SURFACES

A binocular microscope was used to observe the fracture surfaces at low magnification. Figures 11, 14, 17, 20, 23, 26, and 29 show the fracture surfaces of typical test specimens. A rough textured slow growth area can be seen on all specimens where the fracture initiated, see arrows. This area is in contrast to the smooth textured overload failure area which is also quite evident.

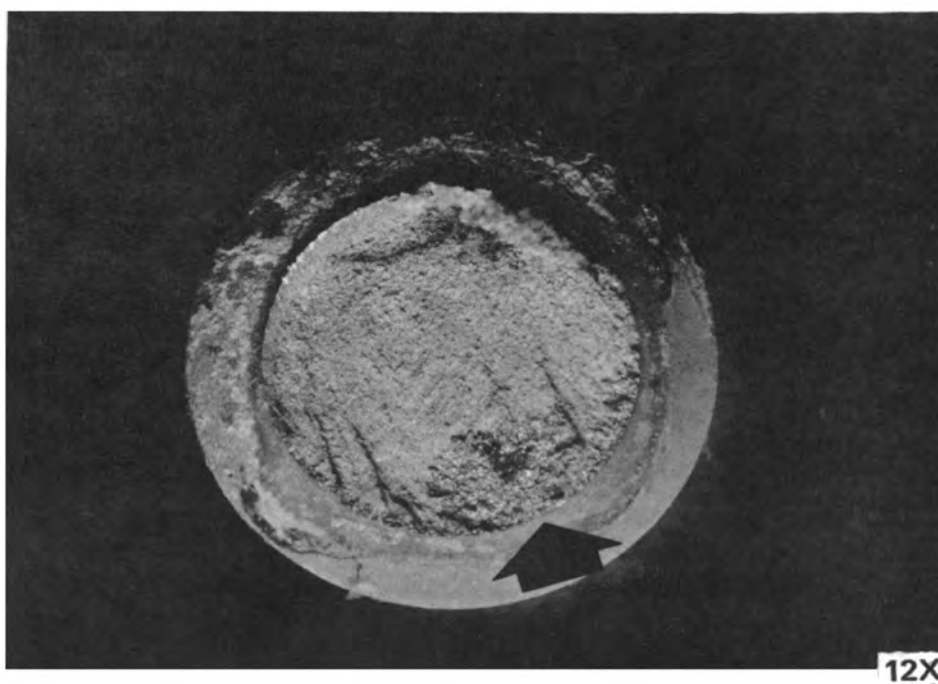
FIGURE 17
MACROPHOTOGRAPHS OF VACUUM CADMIUM (EXPOSED)
FRACTURE SURFACES
